The Holsneset boathouse site: A research excavation report

Stephen Wickler

Locality: Holsneset (Kuholmen)

Site type: boathouse

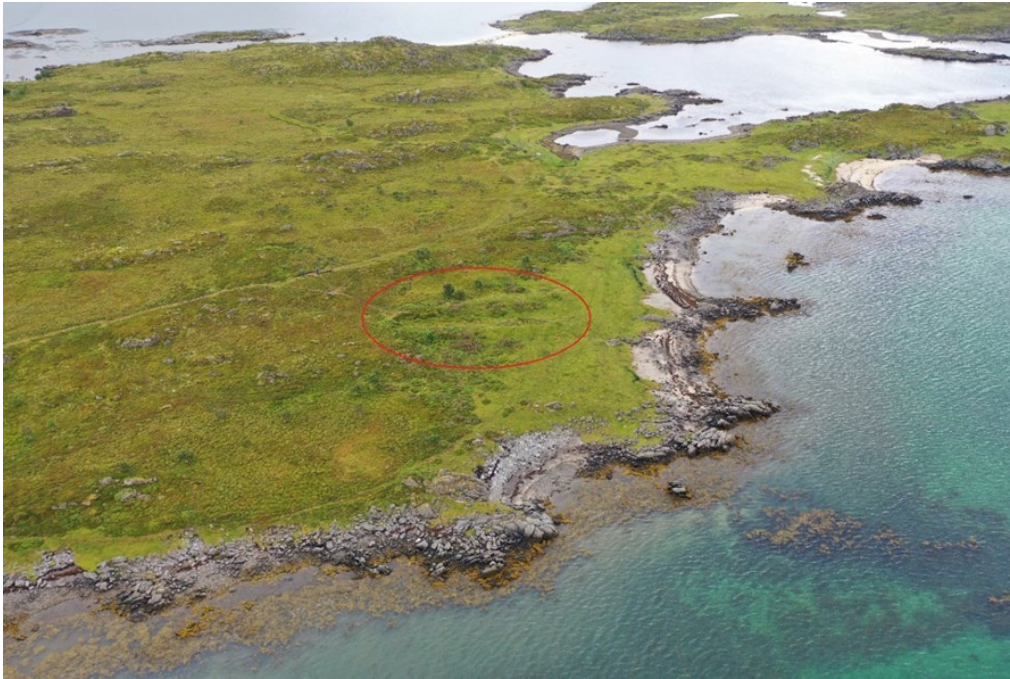
Figure 3. Aerial drone photograph of Holsneset boathouse site looking southeast. Photo: Arctic University Museum of Norway.

The boathouse at Holsneset is monumental in size and described by Simonsen (1991) as the most impressive in all of northern Norway (Fig. 3). Previous documentation of the Holsneset boathouse associated with the boathouse research project prior to the 2024 excavation included digital photogrammetry in 2019 (Fig. 4) and a plan view of the boathouse structure drawn by the author in 2023 (Fig. 5). The boathouse opening faces southwest (210°) and lies 23 m from the turf edge at the high tide mark and 32 m from the seaweed belt in the intertidal zone. The boathouse opening is 1.3 m above the turf edge at the shoreline with a flat slightly sloping surface leading to the boathouse entrance. The internal dimensions of the structure along the estimated inner margin of the boathouse wall mound are c. 39 x 7.2-7.8 m and external dimensions along the outer margin of the wall mound are c. 43 x 20 m. The wall mound has a maximum width of 9 m and is up to 1.4 m high (Fig. 6).

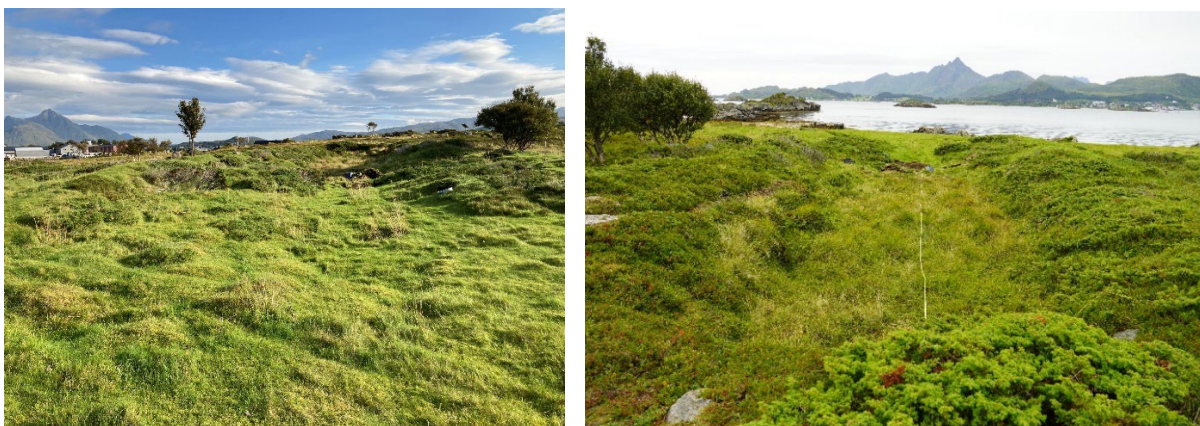
Figure 6. Overview of the Holsneset boathouse. Left: looking inward from the entrance (to north). Right: looking from the wall mound at the inner end towards the entrance (to south). Photo: Stephen Wickler, Arctic University Museum of Norway.

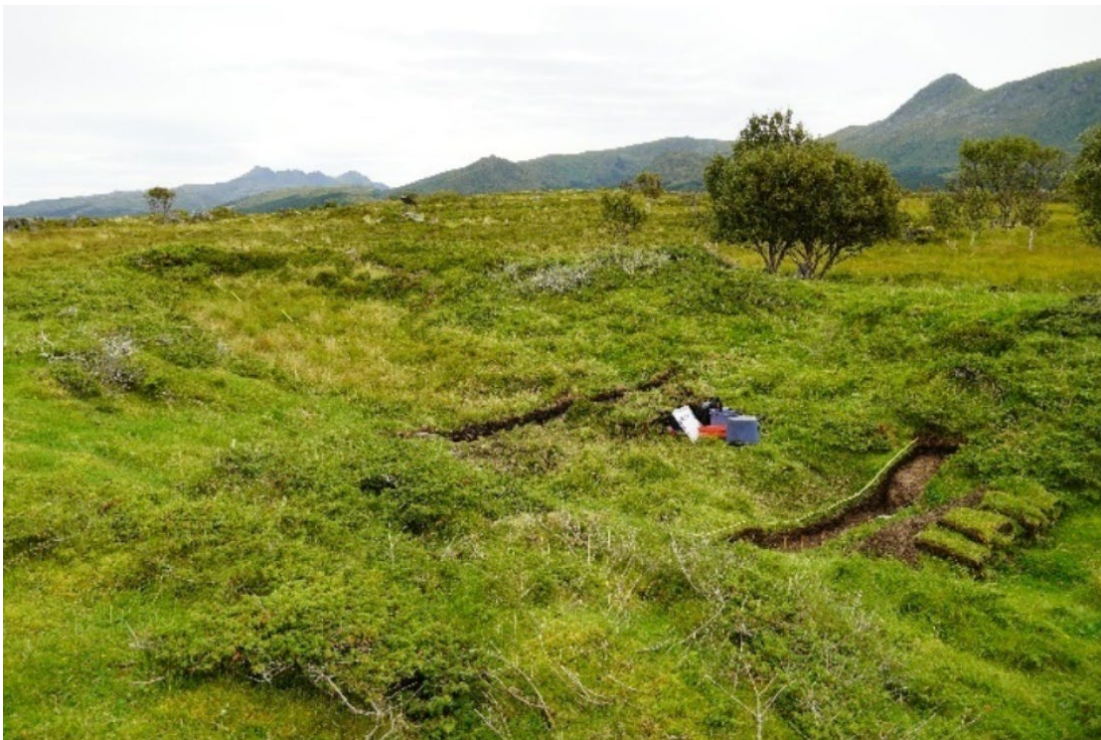
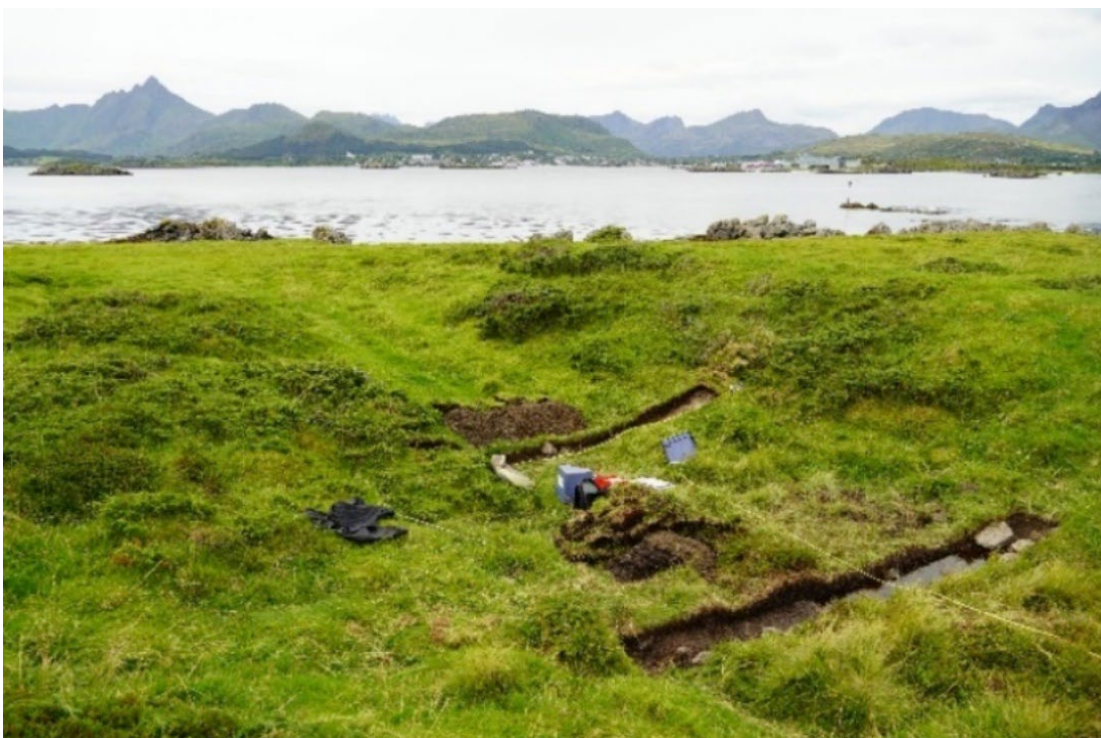
Figure 7. Overview of the Holsneset boathouse and excavation trenches. Top: looking inward from the center of the structure to the northeast. Bottom: looking from the center of the structure towards the entrance to the southwest. Photo: Stephen Wickler, Arctic University Museum of Norway.

The principal excavation objectives were to determine if there were two phases of construction and establish a radiocarbon chronology for boathouse use. This was considered a preliminary investigation to establish a foundation for potential extended future excavation. Based on earlier experience with limited boathouse excavations, it was decided to start with excavation of a 4.5 x 0.5 m trench perpendicular to the long axis of the structure across the floor. It was hoped that this would provide a profile of the floor stratigraphy and document the transition from the floor to inner walls. The initial trench (Trench 1) was placed where surface features suggested that the original entrance to the phase 1 structure may have been located at a distance of 15 m from the inner end of the boathouse floor. A second 4.5 x 0.5 m trench (Trench 2) was placed 4 m further out towards the boathouse opening from Trench 1 at a distance of 19 m from the inner end of the boathouse floor. Trench 2 was placed at the entrance to the original boathouse and documents a transitional zone between the first and second phases of boathouse construction (Fig. 7).

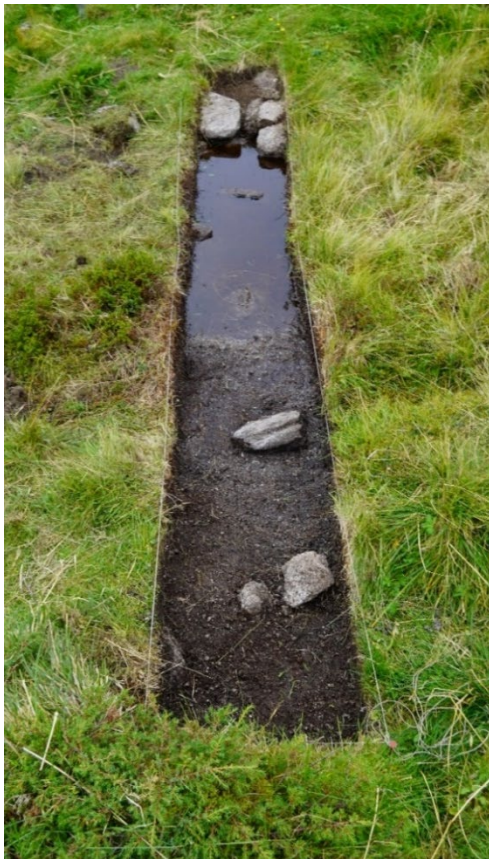
Figure 8. View of Trench 1 following removal of turf layer with standing water (looking west). Photo: Stephen Wickler, Arctic University Museum of Norway.

It became clear during excavation of Trench 1 that this location was within the original boathouse structure and could not document the transition between the two phases of boathouse construction. Excavation was made more difficult by the presence of standing water in the trench due to the waterlogged state of the inner boathouse floor worsened by heavy rain (Fig. 8).

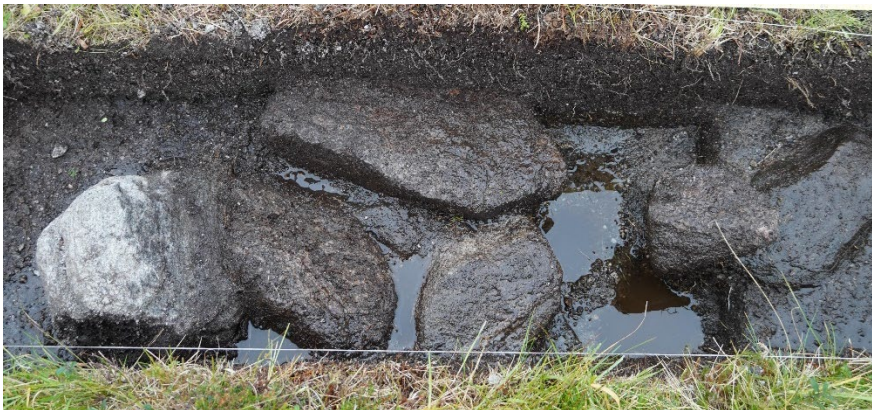
Figure 10. Trench 1 close-up view of stone lined keel trench in center of floor (looking south). Photo: Stephen Wickler, Arctic University Museum of Norway.

Small sediment samples were collected from the three strata (Ts. 16468.5-7). The stratigraphic sequence is straightforward with an upper turf layer (Layer 1) above a thin cultural deposit with few finds (Layer 2). A concentration of stones up to 50 cm in diameter at the center of the floor are interpreted as a stone lined keel trench feature (Fig. 10). Additional large stones up to 40 cm in diameter, including several placed at a downward angle towards the keel trench, are interpreted as stone alignments constructed along both sides of the keel trench (Fig. 11). A 30 cm wide section of the cultural deposit within the keel trench was excavated an additional 10 cm below the general base of excavation. Rapid accumulation of standing water in the trench made further excavation difficult. The waterlogged condition of the central floor area may explain why the stone lining in the keel trench and adjacent stone alignments were necessary to support the keel and lower hull of large vessels within the boathouse.

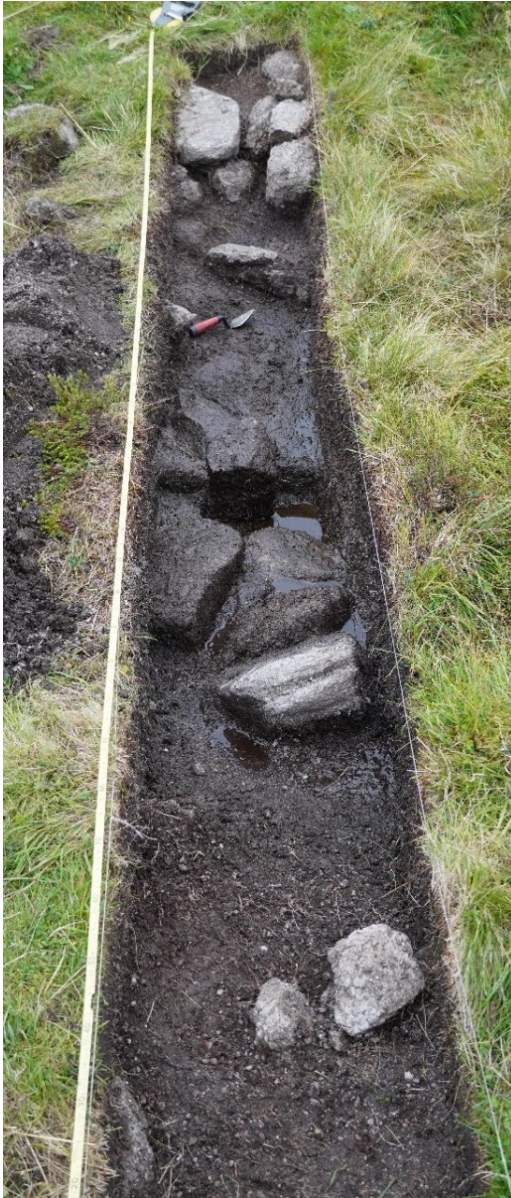
Figure 11 (left). View of Trench 1 at base of excavation showing stone lined keel trench in center of floor (looking west). Photo: Stephen Wickler, Arctic University Museum of Norway.

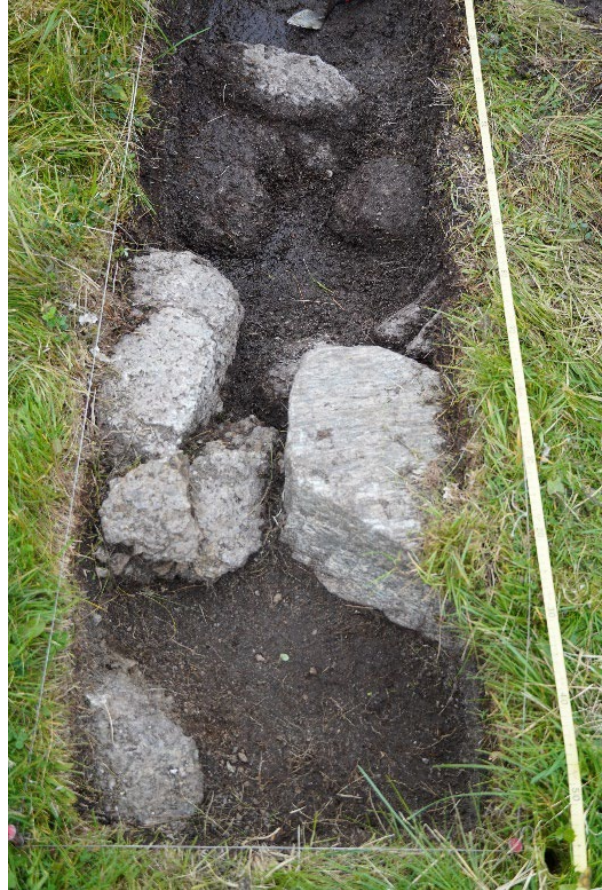
Figure 12 (right). Stones at the western end of Trench 1 likely displaced from a stone facing along the inner wall mound (looking east). Photo: Stephen Wickler, Arctic University Museum of Norway.

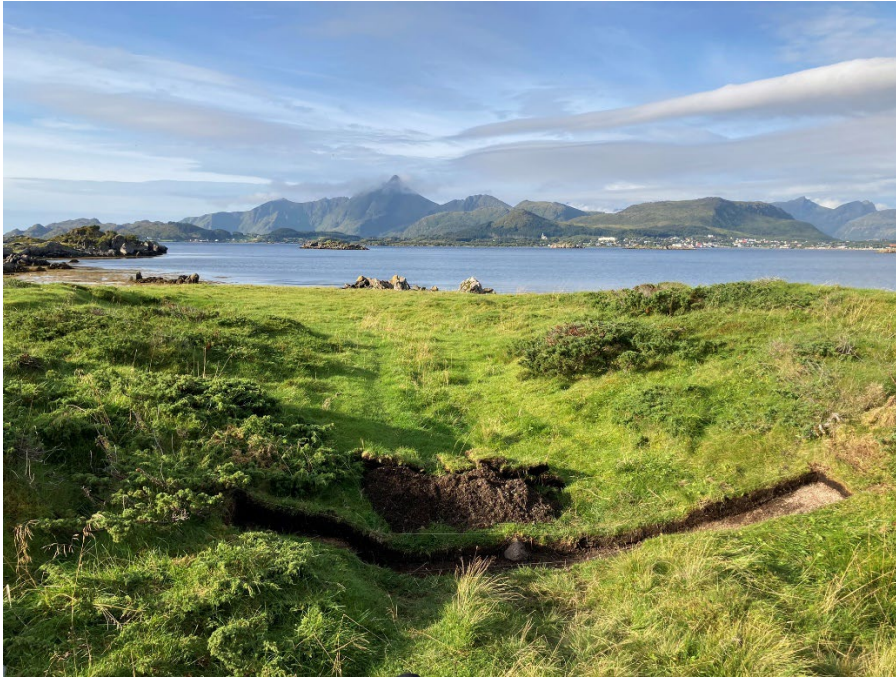
Figure 13. View of Trench 2 location looking towards the boathouse entrance. Photo: Stephen Wickler, Arctic University Museum of Norway.

Trench 2 was a 4.5 x 0.5 m unit placed 4 m from Trench 1 towards the boathouse opening at a distance of 19 m from the inner end of the boathouse floor (Fig. 13). This trench documents a transitional zone between the first and second phases of boathouse construction with construction details from both boathouse structures present. This trench location was somewhat better drained than Trench 1 although standing water still accumulated at the base of the trench. This supports the assertion that it lies beyond the elevated barrier between the two boathouse construction phases at a slightly higher level than the inner floor area. The thin turf layer overlying a mixture of sand and gravel also provides improved drainage. However, it is still low-lying and poorly drained.

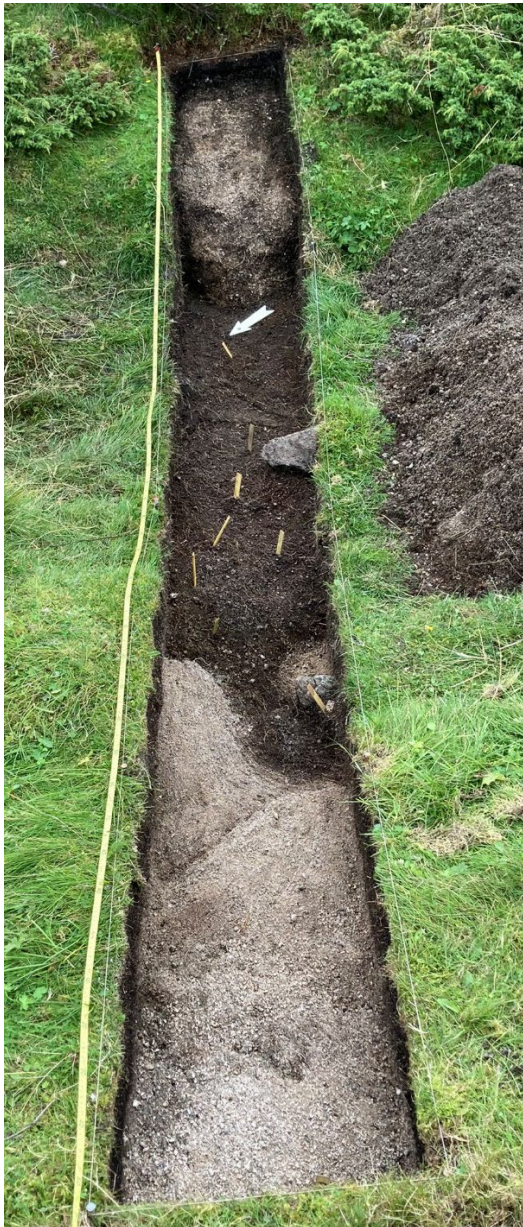
Figure 16 (left). View of Trench 2 showing shell sand wall fill and upper cultural deposit (Layer 2A). Yellow wooden markers at artifact locations (looking east).

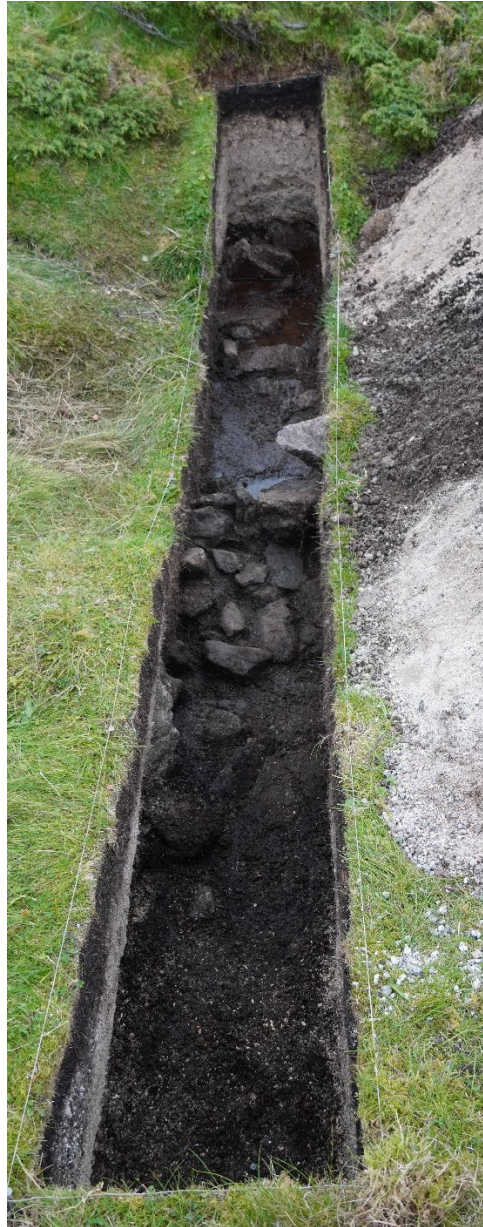
Figure 17 (right). View of Trench 2 at base of excavation showing stacked stone keel support feature in center of floor with stone alignments along both sides (looking east).

A substantial stone structure c. 1 m wide and 15 cm high (20-35 cm bs) was present at the center of the floor constructed of tightly stacked stones ranging from 10-30 cm in diameter (Fig.19). This is interpreted as a feature located at the entrance to the initial boathouse that provided keel support for large vessels being moved in and out of the structure. It is located in the same position on the central floor as the stone lined keel trench in Trench 1. Alignments of stones up to 40 cm in diameter were intentionally placed on both sides of this feature. The stone alignment c. 20 cm west of the keel support is more well defined than that on the eastern side which is diffuse and varies from 20-75 cm in width. These alignments are similar to those in Trench 1 along both sides of the keel trench and served as hull support for large vessels being moved in and out of the boathouse. The presence of a stacked stone structure and stone alignments along the central boathouse floor has not been encountered in other boathouses excavated by the author or any other known boathouse structures. It is interpreted as a necessary measure to prevent large vessels from sinking into the low-lying and poorly drained surface of the floor where this boathouse was constructed. These stone structures are clearly associated with the initial phase of boathouse construction.

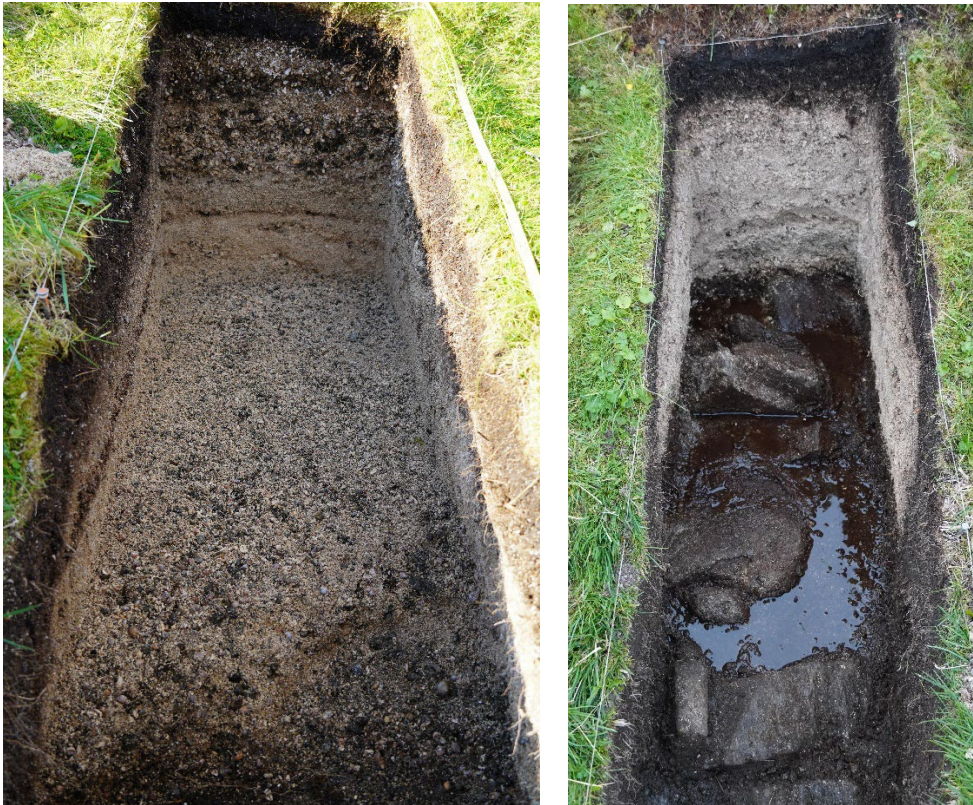
Figure 18. View of shell sand fill profiles in western (left) and eastern (right) walls. Photo: Stephen Wickler, Arctic University Museum of Norway.

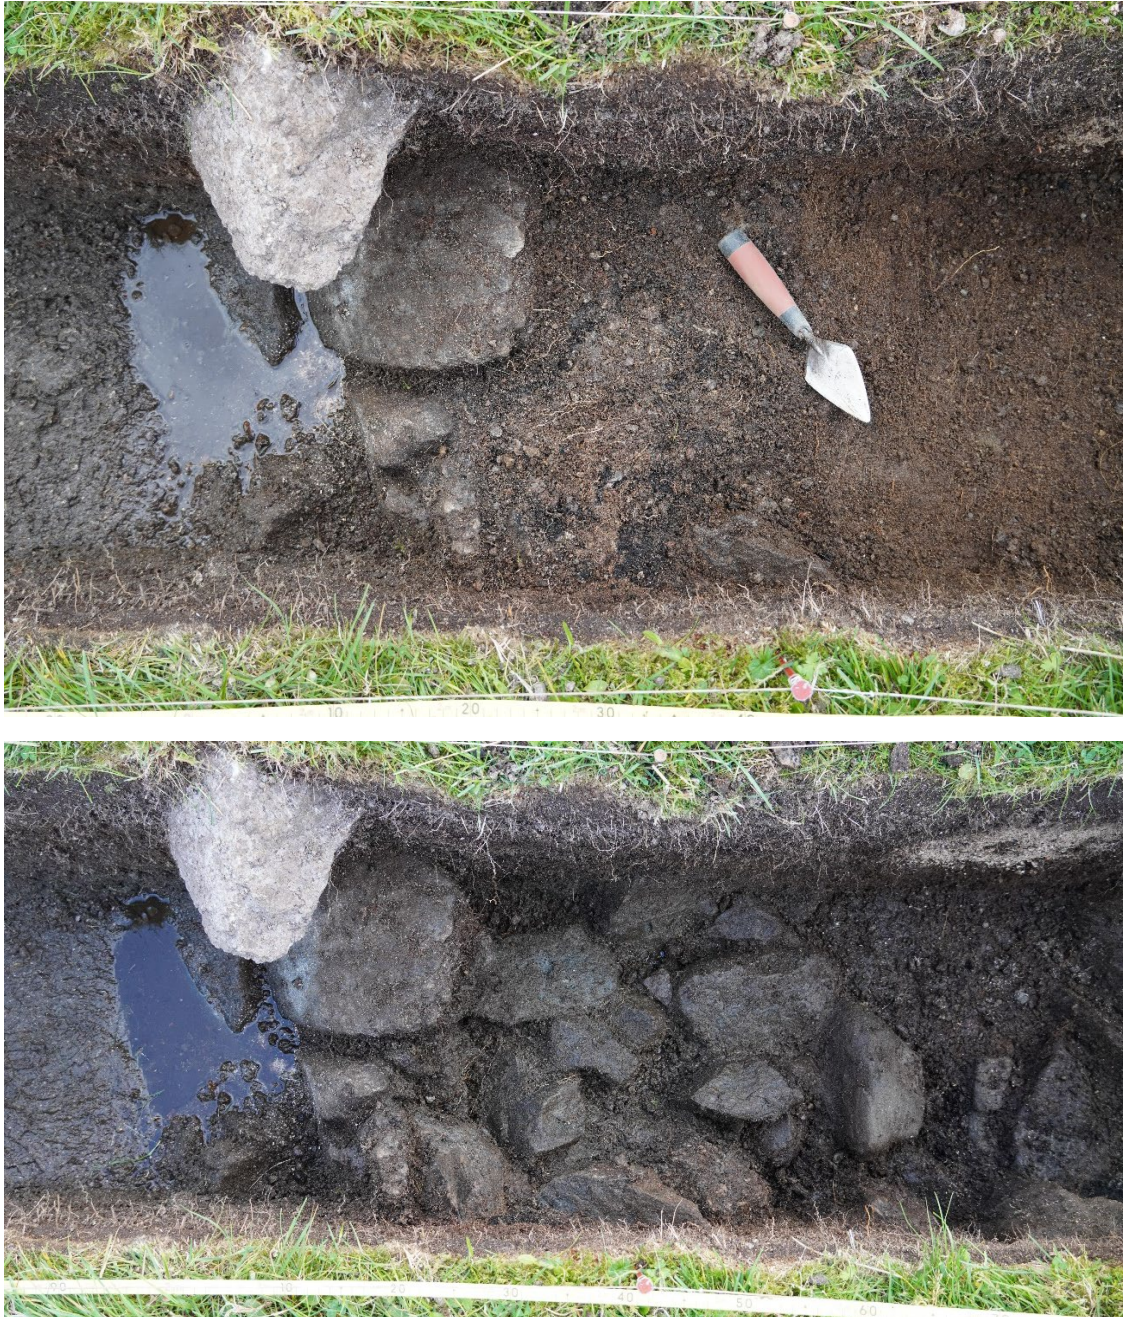
Figure 19. View of central floor area in Trench 2 at the base of Layer 2A where the upper surface of the keel support structure is visible (top) and base of Layer 2B where the entire construction is exposed (bottom) (looking south). Photo: Stephen Wickler, Arctic University Museum of Norway.

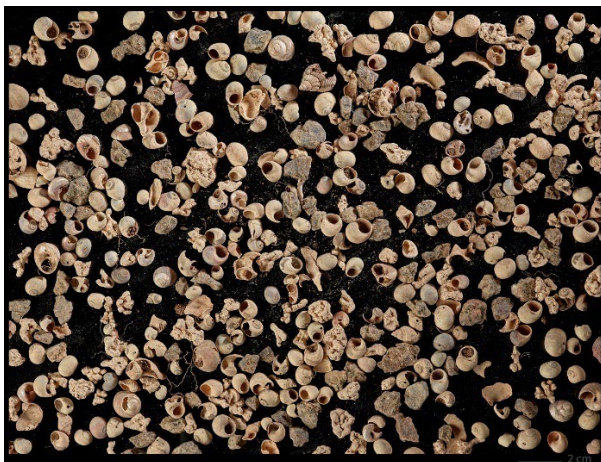
Figure 20. Water-sieved sample of marine shells from a fill band at a depth of c. 28 cm in the western wall mound, Trench 2. Photo: Mari Karlstad, Arctic University Museum of Norway.

Two bands of shell sand fill (Layer 3) from the western wall mound containing a mixture of silt, small stone fragments, coralline algae (*N. rugl*) and marine shells were water-sieved, and samples collected. The upper sample was from 14-19 cm bs and the lower sample from c. 28 cm bs. A majority of the shells were small individuals of the common flat periwinkle that live on seaweed (brown algae) and are commonly washed up in the intertidal zone (Watson and Norton 1987). A limited number of other mollusk species including several periwinkle species, limpets, common whelk, mussel (*Mytilus* sp.) and clam (*Arctica islandica*) were also identified. A few small non-cultural fragments of fish bone were also present in the fill. The shell sand fill could have been easily collected along the shoreline near the boathouse site and would have been an expedient source of fill material for building up the walls of the phase 2 extended boathouse.

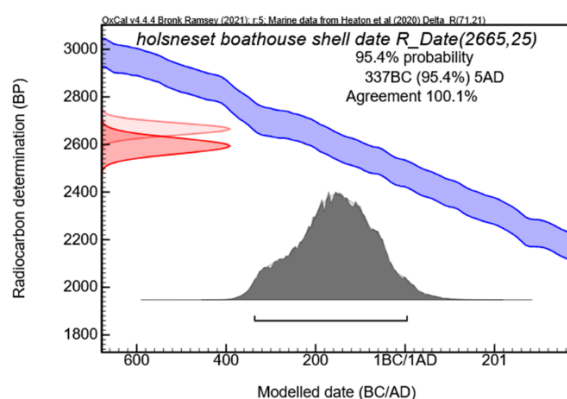
Figure 21. Graph of marine reservoir corrected age range for the marine shell radiocarbon date from boathouse wall fill (Oxcal 4.4.4, Marine20).

As there was insufficient charcoal for a radiocarbon date from the upper cultural deposit in Trench 2 (Layer 2A), a single periwinkle shell (*Littorina obtusata*) from a band of shell sand fill in the western wall at a depth of 28 cm bs (Fig. 20) was submitted as an experiment to test a potential means of dating the final boathouse phase. It was hoped that intact periwinkle shells in fill from the beach might represent individuals that had died fairly recently. The resulting age range of cal 841-792 BC did not support the anticipated outcome. The original date was corrected for marine reservoir effect using a ΔR value of 71 ± 21 recommended for mollusks from northern Norway by Mangerud et al. (2006: 3243). The corrected age range of 337 BC – AD 5 is still substantially earlier than the anticipated date and confirms that old shells were used in the wall fill (Fig. 21).
